**Flood Control Project Maintenance
Levee Inspections**
LMA District Cover Sheet
Spring 2018 Levee Inspection Results

Tehama County Flood Control and Water Conservation District

Spring 2018 Levee Inspection Results

Waterway			Bank	Unit Miles
Unit No. 01 Deer Creek			Left	4.22
	Spring (March - May)	Summer (June - August)	(September - November) Fall	Winter (December - February)
Unit Maintenance Rating (Fall Only)				
Date of Inspection	4/4/2018 - 4/4/2018			
DWR Inspector	Bob Duffey			
Accompanied By	Ryan Teubert Tehama County

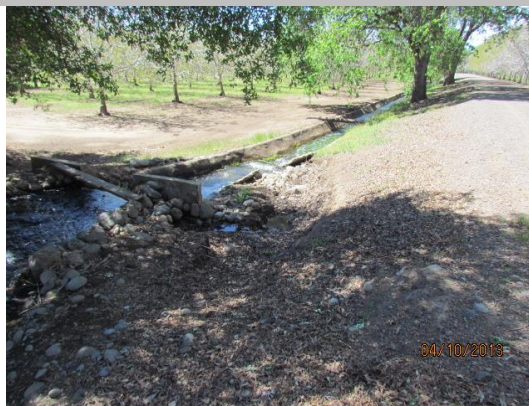
Photo 1 of 1 : SP_2018_NA0019_78_17_20180305_00005.jpg

LM Start	0.01	Rating **	M	Issue No.	17
LM End	0.01	Issue Type +	Ma	Location *	LS
Category	Earthen Levee			GPS Latitude/Longitude	
				Start	End
Item	Erosion / Bank Caving			39.973111 °	39.973111 °
				-121.980466 °	-121.980466 °
DWR ID	DWR_NA0019_01_s _ 2013_17				
Comment Code					
E1 : Note and monitor erosion site.					
Inspector Comment

View of the erosion along the landside slope.

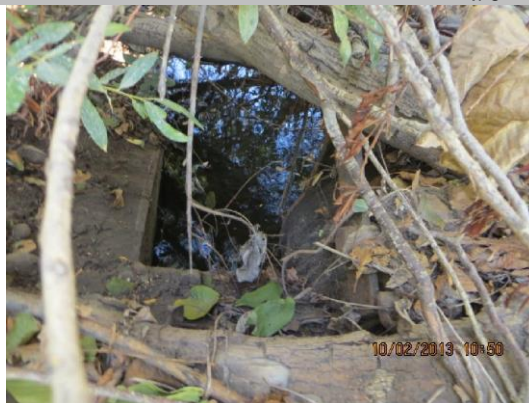
Photo 1 of 1 : UCIP_SP_2018_39838_39058.jpg

LM Start	0.17	Rating **	M	Issue No.	278	
LM End	0.17	Issue Type +	En	Location *		
Category	Supplemental			GPS Latitude/Longitude		
				Start	End	
Item	DWR UCIP Field Study			39.973285 °	39.973285 °	
				-121.983531 °	-121.983531 °	
DWR ID						
Comment Code						
Inspector Comment						
FS_ID:39838						
DS_ID:24685						
EP_NO: N/A						
Repair Type: Non-Urgent						
Crossing Status: Found						
UCIP Comments: No permit identified for this crossing.						
FIELD_STRUCT_DESC: 24-inch reinforced concrete irrigation pipe						
through the levee, 2 feet below the crown. Concrete canal and						
distribution structure on the landside (LS) shoulder. Concrete U-shaped						
headwall and flap gate on the waterside (WS) toe.						
FS Date: 10/2/2013

Concrete U-shaped headwall and flapgate at WS toe.

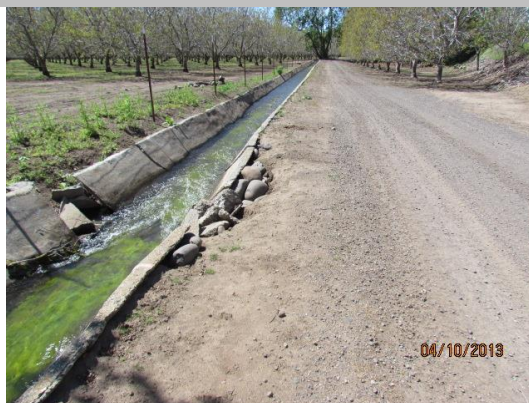
Photo 1 of 1 : SP_2018_NA0019_78_18_20180305_00006.jpg

LM Start	0.41	Rating **	M	Issue No.	18
LM End	0.41	Issue Type +	Ma	Location *	LS
Category	Earthen Levee			GPS Latitude/Longitude	
				Start	End
Item	Erosion / Bank Caving			39.972560 °	39.972560 °
				-121.987759 °	-121.987759 °
DWR ID	DWR_NA0019_01_s_2013_18				
Comment Code					
E1 : Note and monitor erosion site.					
Inspector Comment

View of the erosion along the landside slope.

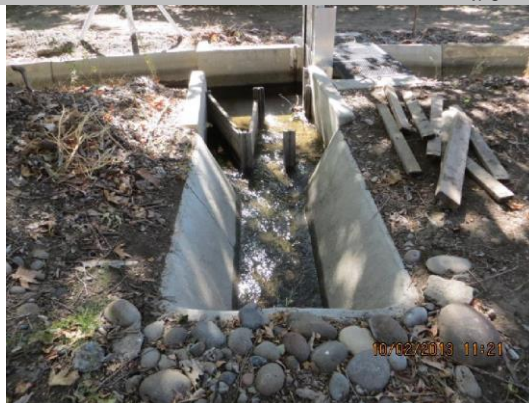
Photo 1 of 3 : UCIP_SP_2018_39839_39063.jpg

LM Start	0.49	Rating **	M	Issue No.	279
LM End	0.49	Issue Type +	En	Location *	
Category	Supplemental			GPS Latitude/Longitude	
				Start	End
Item	DWR UCIP Field Study			39.972280 °	39.972280 °
				-121.989227 °	-121.989227 °
DWR ID					
Comment Code					
Inspector Comment					
FS_ID:39839 DS_ID:24686 EP_NO: N/A Repair Type: Non-Urgent Crossing Status: Found UCIP Comments: No permit identified for crossing. FIELD_STRUCT_DESC: 20-inch reinforced concrete irrigation pipe through the levee, 2 feet below the crown. Concrete canal and distribution structure with slat boards on the landside (LS) shoulder. FS Date: 10/2/2013

Concrete canal/distribution box on LS shoulder.

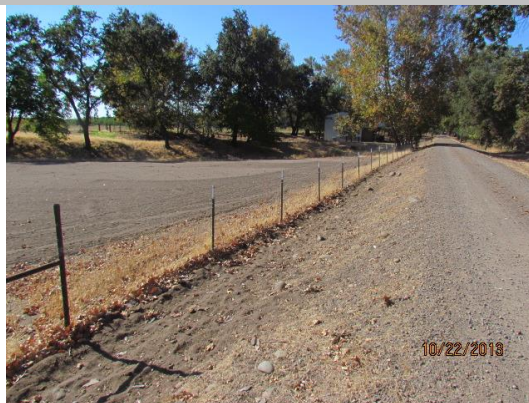
Photo 1 of 1 : SP_2018_NA0019_78_21_20180305_00009.jpg

View of the erosion caused by livestock on both slope of the levee.

LM Start	1.47	Rating **	M	Issue No.	21
LM End	1.47	Issue Type +	Ma	Location *	LS
Category	Earthen Levee			GPS Latitude/Longitude	
				Start	End
Item	Slope Stability			39.969702 °	39.969702 °
				-122.006975 °	-122.006975 °
DWR ID	DWR_NA0019_01_f_2013_21				
Comment Code					
S2 : Repair the levee slope damaged by foot traffic and prevent access where possible.					
Inspector Comment					
Keep livestock off levee and repair damage.

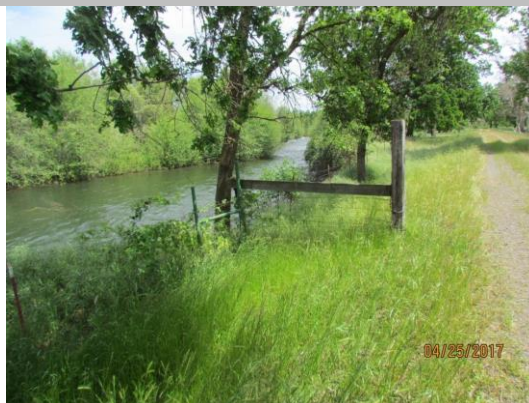
Photo 1 of 1 : SP_2018_NA0019_78_42_20180305_00016.jpg

View of the erosion along the waterside toe.

LM Start	1.55	Rating **	A/W	Issue No.	42
LM End	1.58	Issue Type +	Ma	Location *	WS
Category	Earthen Levee			GPS Latitude/Longitude	
				Start	End
Item	Erosion / Bank Caving			39.969193 °	39.969052 °
				-122.008458 °	-122.008920 °
DWR ID	DWR_NA0019_01_s_2017_42				
Comment Code					
E2 : Schedule repair of erosion site prior to the next inspection.					
Inspector Comment					
Repair the erosion along the water side toe.

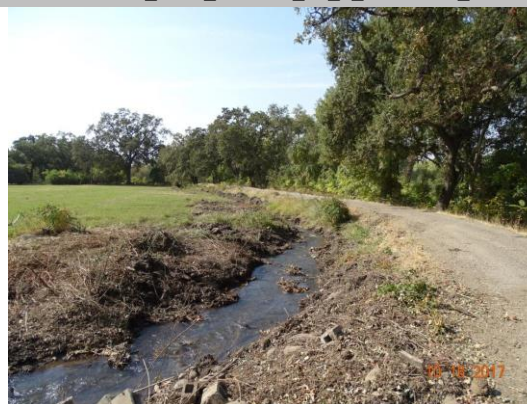
Photo 1 of 2 : SP_2018_NA0019_78_2_20180305_00001.jpg

View of the irrigation ditch along the landside toe.

LM Start	1.79	Rating **	U	Issue No.	2
LM End	2.22	Issue Type +	En	Location *	LS
Category	Earthen Levee			GPS Latitude/Longitude	
				Start	End
Item	Encroachments			39.969443 °	39.966921 °
				-122.012261 °	-122.019469 °
DWR ID	DWR_NA0019_01_s_2012_2				
Comment Code					
DT : Ditch					
Inspector Comment					
Repair the cleaned out irrigation ditch along the landside toe.

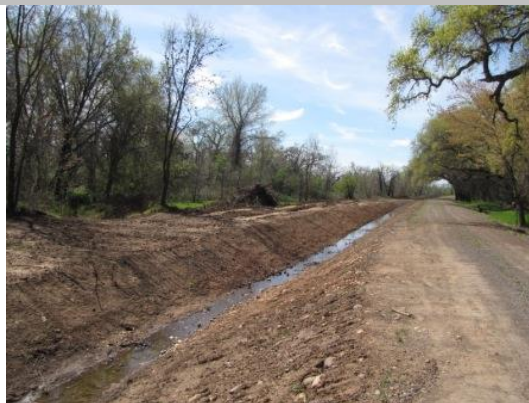
Photo 2 of 2 : SP_2018_NA0019_78_2_20180305_00002.jpg

View of an agricultural ditch along the levee toe.

LM Start	1.79	Rating **	U	Issue No.	2 (cont)	
LM End	2.22	Issue Type +	En	Location *	LS	
Category	Earthen Levee			GPS Latitude/Longitude		
				Start		End
Item	Encroachments			39.969443 °		39.966921 °
				-122.012261 °		-122.019469 °
DWR ID	DWR_NA0019_01_s_2012_2					
Comment Code						
DT : Ditch						
Inspector Comment						
Repair the cleaned out irrigation ditch along the landside toe.

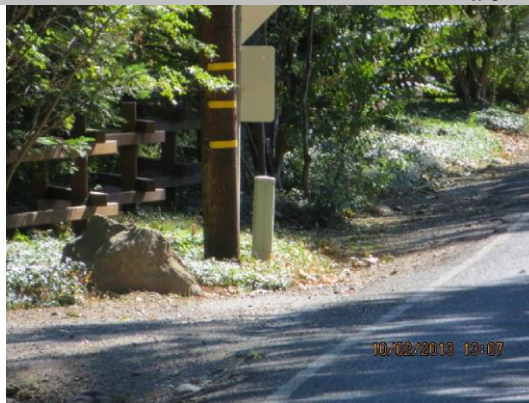
Photo 1 of 3 : UCIP_SP_2018_39837_39067.jpg

LM Start	1.88	Rating **	M	Issue No.	281
LM End	1.88	Issue Type +	En	Location *	
Category	Supplemental			GPS Latitude/Longitude	
				Start	End
Item	DWR UCIP Field Study			39.969156 °	39.969156 °
				-122.013809 °	-122.013809 °
DWR ID					
Comment Code					
Inspector Comment					
FS_ID:39837					
DS_ID:24690					
EP_NO: N/A					
Repair Type: Non-Urgent					
Crossing Status: Found					
UCIP Comments: No permit identified for this crossing.					
FIELD_STRUCT_DESC: 4-inch steel communications conduit through the levee, at an unknown depth. Junction box off the landside (LS) toe next to JP and roadway. Conduit visible on upstream side of bridge at Deer Creek crossing.					
FS Date: 10/2/2013

Communication box off LS shoulder next to roadway.

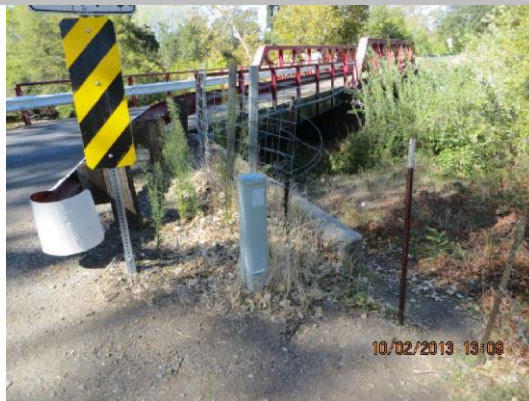
Photo 2 of 3 : UCIP_SP_2018_39837_39066.jpg

Communication box on WS shoulder.

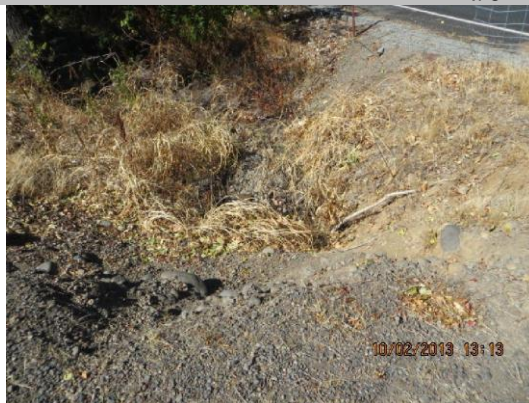
Photo 2 of 3 : UCIP_SP_2018_51438_36924.jpg

Comment Code						
Inspector Comment						
FS_ID:51438 DS_ID:20769 EP_NO: N/A Repair Type: Urgent Crossing Status: Found UCIP Comments: 12/05/2016 same as last inspection. Crossing remains "Urgent" WS opened during flood season due to damaged flap gate. (O. Magana - DWR UCIP)10/02/2013 Flapgate missing or burried on WS toe. Pipe partially blocked by soil on WS toe. (W. Wylie - DWR UCIP) FIELD_STRUCT_DESC: 24-inch corrugated metal drainage pipe through the levee, 7 feet below the crown. Flap gate located on the waterside (WS) end. A 5-foot by 5-foot concrete control structure located on the landside (LS) toe. [Additional Reference(s): DWR Levee Log, 1992. USACE Sacramento O&M Manual Unit 509, March 1957, As-built drawing no. 50-4-2394 (Station 176+10)]. FS Date: 12/5/2016

Outlet on WS toe.

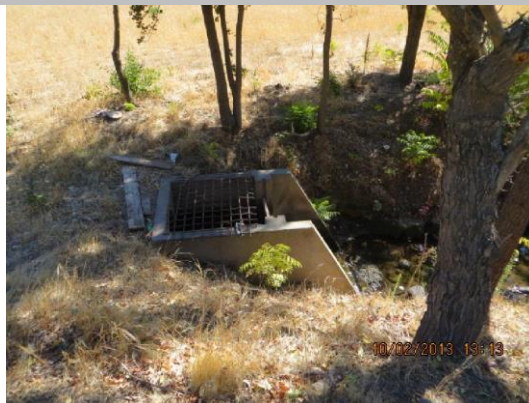
Photo 3 of 3 : UCIP_SP_2018_51438_36923.jpg

Concrete control structure on LS toe.

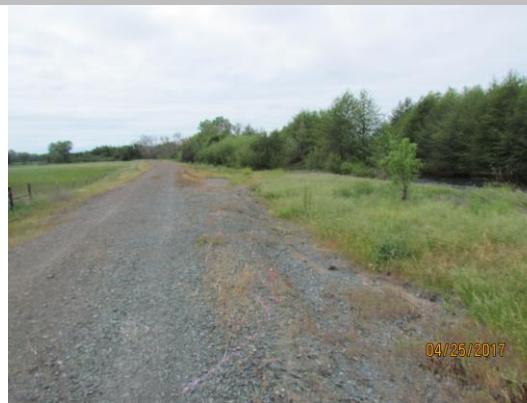
Photo 1 of 1 : SP_2018_NA0019_78_39_20180305_00014.jpg

View of erosion along the waterside slope.

LM Start	2.53	Rating **	M	Issue No.	39
LM End	2.53	Issue Type +	Ma	Location *	WS
Category	Earthen Levee			GPS Latitude/Longitude	
				Start	End
Item	Erosion / Bank Caving			39.966675 °	39.966675 °
				-122.024988 °	-122.024988 °
DWR ID	DWR_NA0019_01_s_2017_39				
Comment Code					
E2 : Schedule repair of erosion site prior to the next inspection.					
Inspector Comment					
Repair the erosion along the water side slope.

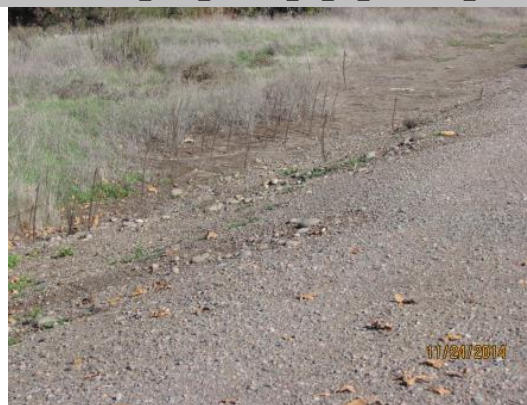
Photo 1 of 1 : SP_2018_NA0019_78_38_20180305_00013.jpg

LM Start	2.86	Rating **	M	Issue No.	38
LM End	2.86	Issue Type +	Ma	Location *	LS
Category	Earthen Levee			GPS Latitude/Longitude	
				Start	End
Item	Slope Stability			39.963928 °	39.963928 °
				-122.030120 °	-122.030120 °
DWR ID	DWR_NA0019_01_f_2014_38				
Comment Code					
S1 : Repair slope instability.					
Inspector Comment

View of erosion from the cattle on both slopes.

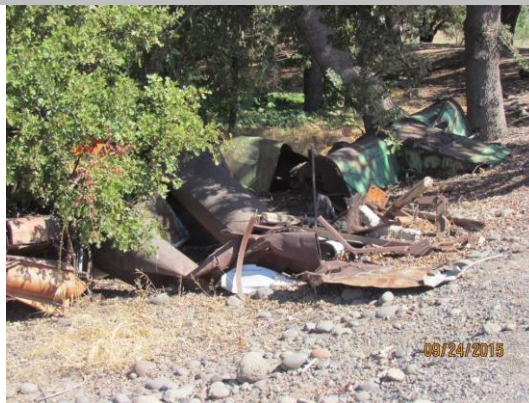
Photo 1 of 1 : SP_2018_NA0019_78_37_20180305_00012.jpg

View of the scrap equipment along the waterside toe.

LM Start	3.06	Rating **	M	Issue No.	37
LM End	3.06	Issue Type +	En	Location *	WS
Category	Earthen Levee			GPS Latitude/Longitude	
				Start	End
Item	Encroachments			39.961798 °	39.961798 °
				-122.032723 °	-122.032723 °
DWR ID	DWR_NA0019_01_f_2015_37				
Comment Code					
EQ : Equipment					
Inspector Comment					
Remove the scrap equipment along the waterside toe.

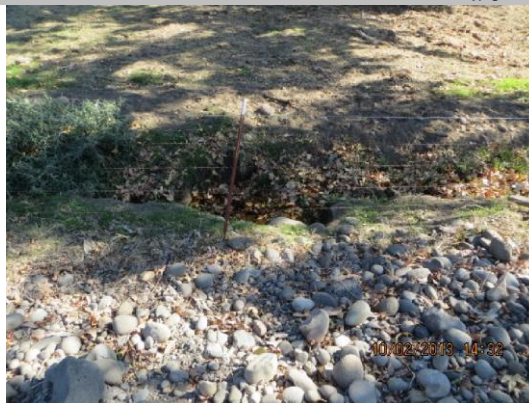
Photo 1 of 3 : UCIP_SP_2018_22825_38952.jpg

LM Start	3.29	Rating **	M	Issue No.	285	
LM End	3.29	Issue Type +	En	Location *		
Category	Supplemental			GPS Latitude/Longitude		
				Start	End	
Item	DWR UCIP Field Study			39.947484 °	39.947484 °	
				-122.049011 °	-122.049011 °	
DWR ID						
Comment Code						
Inspector Comment						
FS_ID:22825						
DS_ID:20766						
EP_NO: N/A						
Repair Type: Non-Urgent						
Crossing Status: Indicator Found						
UCIP Comments: Pipe buried. Water flows to low spot and dissapears, but pipe not visible.						
FIELD_STRUCT_DESC: 24-inch pipe through the levee 8-feet below the crown, flap gate on waterward end. Originally included in O+M manual (1957). As-built drawing No. 50-4-2394.						
FS Date: 10/2/2013

Low spot with water on LS toe.

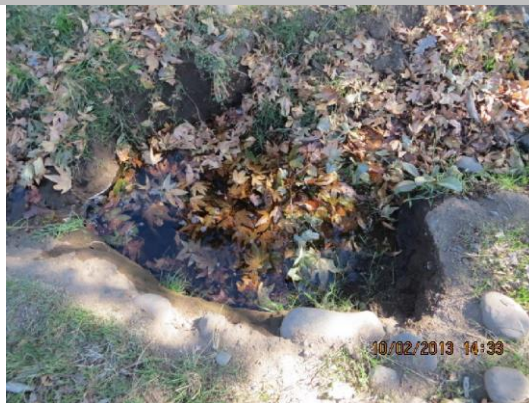
Photo 2 of 3 : UCIP_SP_2018_22825_38951.jpg

Low spot with water on LS toe.

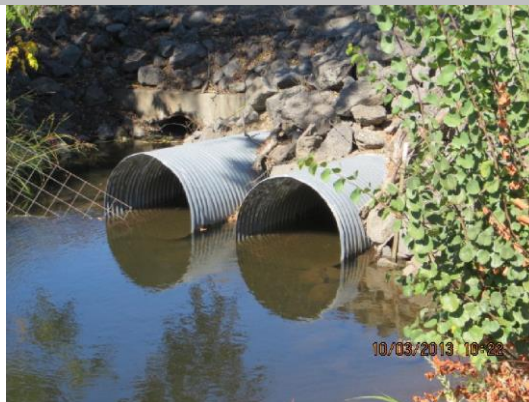
Photo 2 of 3 : UCIP_SP_2018_23007_39069.jpg

Pipe visible on LS toe.

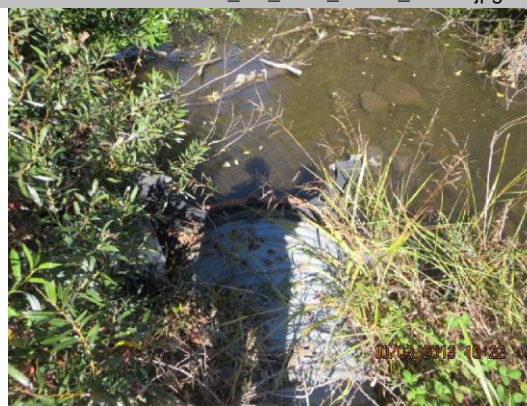
Photo 3 of 3 : UCIP_SP_2018_23007_39068.jpg

LM Start	3.59	Rating **	M	Issue No.	286 (cont)	
LM End	3.59	Issue Type +	En	Location *		
Category	Supplemental			GPS Latitude/Longitude		
				Start	End	
Item	DWR UCIP Field Study			39.945964 °	39.945964 °	
				-122.054229 °	-122.054229 °	
DWR ID						
Comment Code						
Inspector Comment						
FS_ID:23007 DS_ID:24687 EP_NO: N/A Repair Type: Non-Urgent Crossing Status: Found UCIP Comments: No permit identified for this crossing. FIELD_STRUCT_DESC: 48-inch corrugated metal drainage pipe through the levee, 6 feet below the crown. Flap gate on the waterside (WS) end. FS Date: 10/3/2013

Flapgate visible on WS toe.

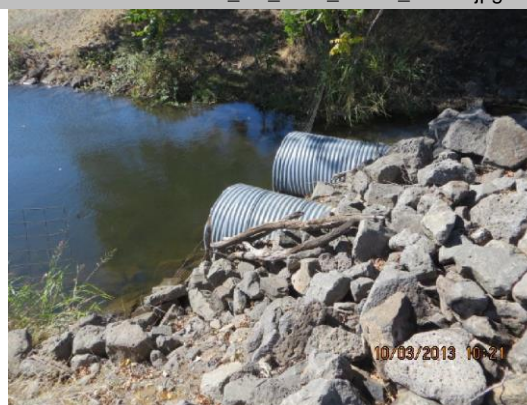
Photo 1 of 3 : UCIP_SP_2018_39836_39073.jpg

LM Start	3.60	Rating **	M	Issue No.	287	
LM End	3.60	Issue Type +	En	Location *		
Category	Supplemental			GPS Latitude/Longitude		
				Start	End	
Item	DWR UCIP Field Study			39.945952 °	39.945952 °	
				-122.054259 °	-122.054259 °	
DWR ID						
Comment Code						
Inspector Comment						
FS_ID:39836						
DS_ID:24688						
EP_NO: N/A						
Repair Type: Non-Urgent						
Crossing Status: Found						
UCIP Comments: No permit identified for this crossing. Brush should be removed from flapgate outlet.						
FIELD_STRUCT_DESC: 48-inch corrugated metal drainage pipe through the levee, 6 feet below the crown. Flap gate on the waterside (WS) end.						
FS Date: 10/3/2013

Pipe visible on LS toe.

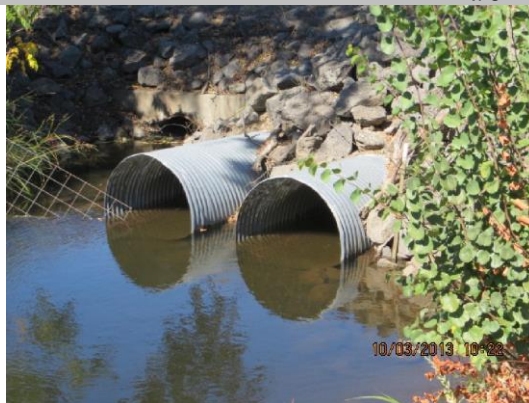
Photo 2 of 3 : UCIP_SP_2018_39836_39072.jpg

Pipe visible on LS toe.

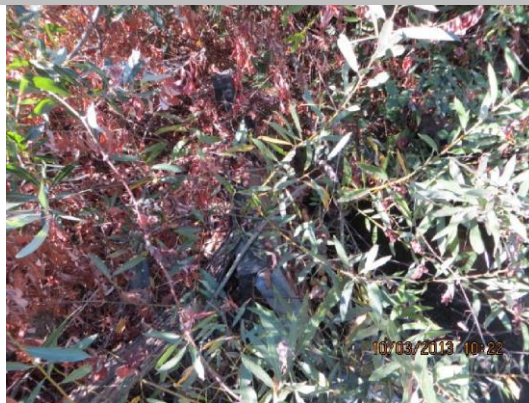
Photo 3 of 3 : UCIP_SP_2018_39836_39071.jpg

Flapgate visible on WS toe covered in brush.

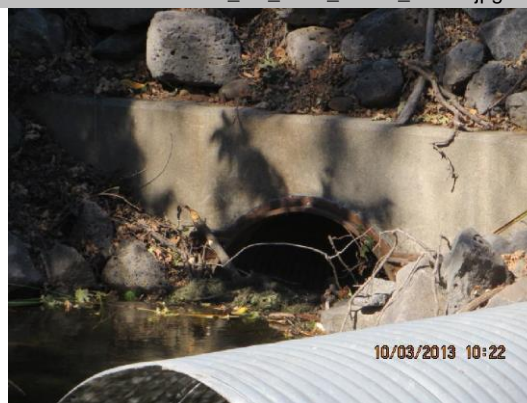
Photo 1 of 3 : UCIP_SP_2018_51439_39076.jpg

Comment Code					
Inspector Comment					
FS_ID:51439 DS_ID:24689 EP_NO: N/A Repair Type: Non-Urgent Crossing Status: Found UCIP Comments: 12/05/2016 same as last inspection. Crossing has been downgraded from Urgent to Non-Urgent WS flap gate is closed. Recommend clearing dense vegetation on WS and completing an internal inspection to determine condition of the pipe through the levee. (O. Magana - DWR UCIP)10/03/2013 Flapgate does not fully close. Needs brush cleared away from outlet. (W. Wylie - DWR UCIP) FIELD_STRUCT_DESC: 36-inch corrugated metal drainage pipe through the levee, 7 feet below the crown. Flap gate located on the waterside (WS) end. Concrete headwall located on the landside (LS) toe. FS Date: 12/5/2016

Pipe visible at headwall on LS toe.

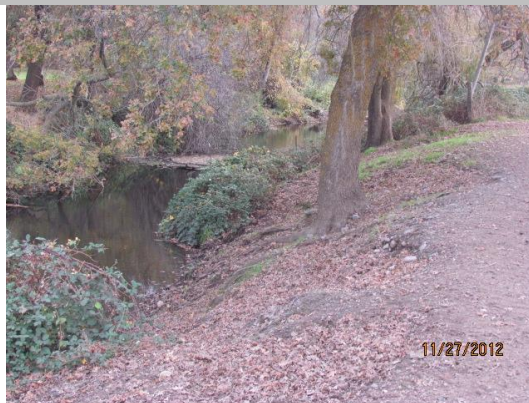
Photo 1 of 1 : SP_2018_NA0019_78_15_20180305_00003.jpg

LM Start	3.68	Rating **	M	Issue No.	15
LM End	3.68	Issue Type +	Ma	Location *	LS
Category	Earthen Levee			GPS Latitude/Longitude	
				Start	End
Item	Slope Stability			39.945045 °	39.945045 °
				-122.053469 °	-122.053469 °
DWR ID	DWR_NA0019_01_f_2012_15				
Comment Code					
S1 : Repair slope instability.					
Inspector Comment

View of the erosion caused by livestock along the landside slope.

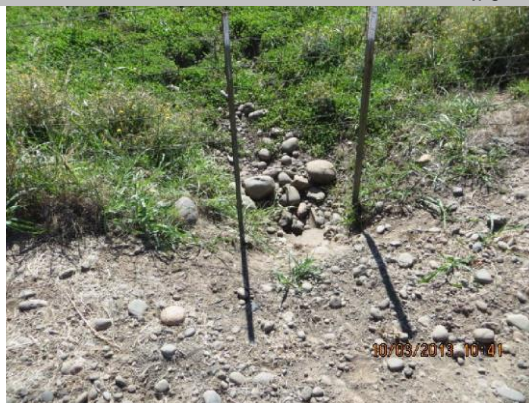
Photo 1 of 3 : UCIP_SP_2018_23094_39307.jpg

LM Start	3.75	Rating **	M	Issue No.	289	
LM End	3.75	Issue Type +	En	Location *		
Category	Supplemental			GPS Latitude/Longitude		
				Start	End	
Item	DWR UCIP Field Study			39.944460 °	39.944460 °	
				-122.053930 °	-122.053930 °	
DWR ID						
Comment Code						
Inspector Comment						
FS_ID:23094 DS_ID:20763 EP_NO: N/A Repair Type: Non-Urgent Crossing Status: Found UCIP Comments: Erosion on WS toe. FIELD_STRUCT_DESC: 12-inch concrete drainage pipe, through the levee, 2-feet below the crown. FS Date: 10/3/2013

Concrete pipe at inlet on LS toe.

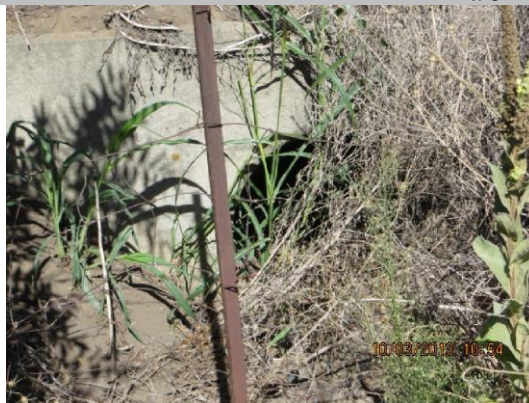
Photo 1 of 3 : UCIP_SP_2018_21741_36937.jpg

FS_ID:21741
DS_ID:20760
EP_NO: N/A
Repair Type: No Action Needed
Crossing Status: Found
UCIP Comments:
FIELD_STRUCT_DESC: 24-inch corrugated metal drainage pipe through the levee, 5 feet below the crown. Flap gate on the waterside (WS) end. Headwalls on both sides of levee. [Additional Reference(s): DWR Levee Log, 1992. USACE Sacramento O&M Manual 509, March 1957, (Assumed Station 5+00) Drawing No. 50-4-2394].
FS Date: 10/3/2013

Pipe and concrete headwall on LS toe.

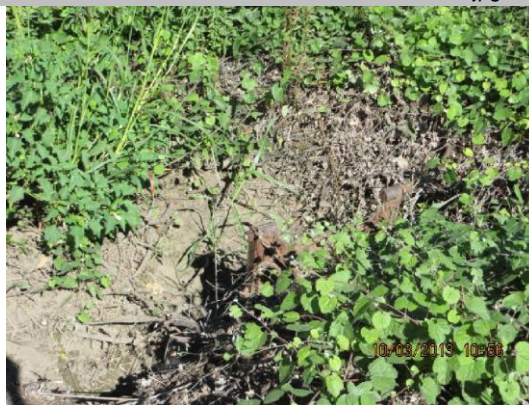
Photo 2 of 3 : UCIP_SP_2018_21741_36936.jpg

Flapgate on WS toe.

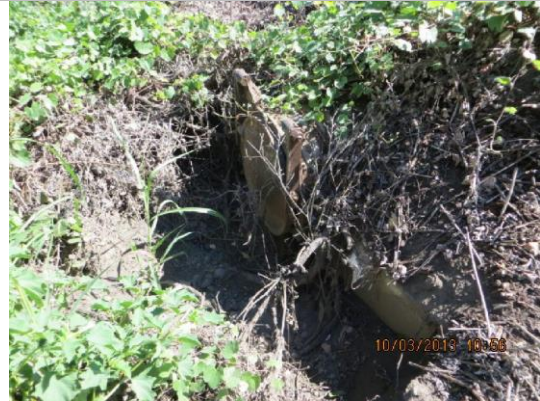
Photo 3 of 3 : UCIP_SP_2018_21741_36935.jpg

LM Start	4.03	Rating **	A/W	Issue No.	291 (cont)	
LM End	4.03	Issue Type +	Ma	Location *		
Category	Supplemental			GPS Latitude/Longitude		
				Start	End	
Item	DWR UCIP LMA Responsibility			39.941574 °	39.941574 °	
				-122.057597 °	-122.057597 °	
DWR ID						
Comment Code						
Inspector Comment						
FS_ID:21741						
DS_ID:20760						
EP_NO: N/A						
Repair Type: No Action Needed						
Crossing Status: Found						
UCIP Comments:						
FIELD_STRUCT_DESC: 24-inch corrugated metal drainage pipe						
through the levee, 5 feet below the crown. Flap gate on the waterside						
(WS) end. Headwalls on both sides of levee. [Additional Reference(s):						
DWR Levee Log, 1992. USACE Sacramento O&M Manual 509, March						
1957, (Assumed Station 5+00) Drawing No. 50-4-2394].						
FS Date: 10/3/2013

Flapgate and concrete headwall on WS toe.

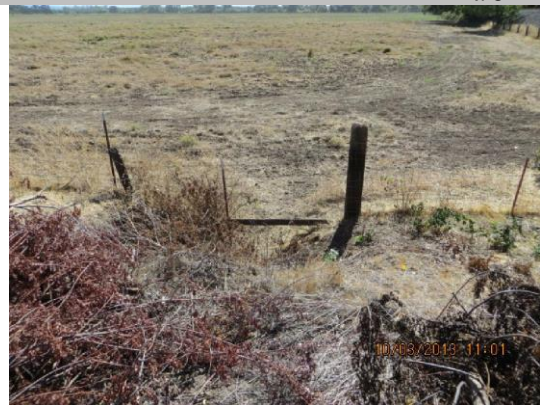
Photo 1 of 3 : UCIP_SP_2018_51441_36942.jpg

LM Start	4.10	Rating **	U	Issue No.	292
LM End	4.10	Issue Type +	Ma	Location *	
Category	Supplemental			GPS Latitude/Longitude	
				Start	End
Item	DWR UCIP LMA Responsibility			39.941002 °	39.941002 °
				-122.058711 °	-122.058711 °
DWR ID					
Comment Code					
Inspector Comment					
FS_ID:51441 DS_ID:20762 EP_NO: N/A Repair Type: Urgent Crossing Status: Found UCIP Comments: 12/05/2016 unable to complete inspection -- unable to locate. (O. Magana - DWR UCIP)10/03/2013 Gate missing from WS toe. (W. Wylie - DWR UCIP) FIELD_STRUCT_DESC: 24-inch corrugated metal drainage pipe through the levee, 5.5 feet below the crown. Flap gate located on the waterside (WS) end. Concrete headwall located on the landside (LS) toe. [Additional Reference(s): DWR Levee Log, 1992. USACE Sacramento O&M Manual Unit 509, March 1957, As-built drawing no. 50-4-2394 (Station 0+65)]. FS Date: 12/5/2016

Inlet on LS toe.

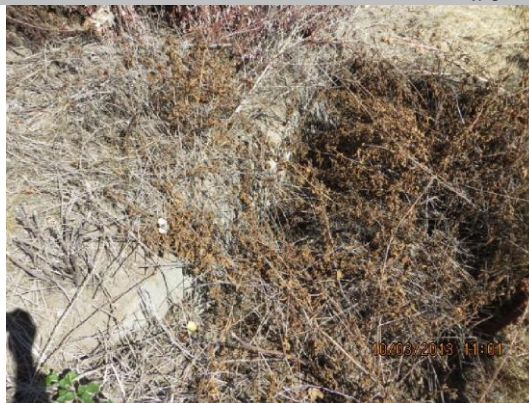
Photo 2 of 3 : UCIP_SP_2018_51441_36941.jpg

Comment Code						
Inspector Comment						
FS_ID:51441 DS_ID:20762 EP_NO: N/A Repair Type: Urgent Crossing Status: Found UCIP Comments: 12/05/2016 unable to complete inspection -- unable to locate. (O. Magana - DWR UCIP)10/03/2013 Gate missing from WS toe. (W. Wylie - DWR UCIP) FIELD_STRUCT_DESC: 24-inch corrugated metal drainage pipe through the levee, 5.5 feet below the crown. Flap gate located on the waterside (WS) end. Concrete headwall located on the landside (LS) toe. [Additional Reference(s): DWR Levee Log, 1992. USACE Sacramento O&M Manual Unit 509, March 1957, As-built drawing no. 50-4-2394 (Station 0+65)]. FS Date: 12/5/2016

Concrete headwall at inlet on LS toe.

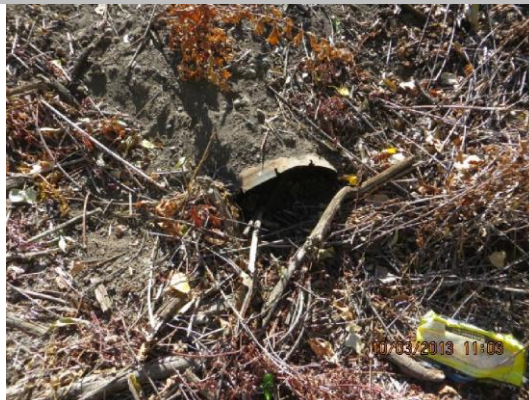
Photo 3 of 3 : UCIP_SP_2018_51441_36940.jpg

Flap gate missing from pipe at WS toe.

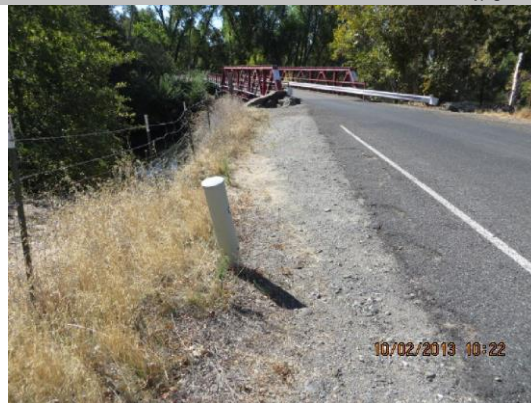
Photo 1 of 3 : UCIP_SP_2018_40789_39057.jpg

LM Start	0.31	Rating **	M	Issue No.	21
LM End	0.31	Issue Type +	En	Location *	
Category	Supplemental			GPS Latitude/Longitude	
				Start	End
Item	DWR UCIP Field Study			39.970256 °	39.970256 °
				-122.014471 °	-122.014471 °
DWR ID					
Comment Code					
Inspector Comment					
FS_ID:40789 DS_ID:24683 EP_NO: N/A Repair Type: Non-Urgent Crossing Status: Found UCIP Comments: No permit identified for this crossing. FIELD_STRUCT_DESC: 4-inch galvanized iron communications conduit through the levee, at an unknown depth. Pipe visible on upstream side of bridge. FS Date: 10/2/2013

Communication line access box on WS shoulder.

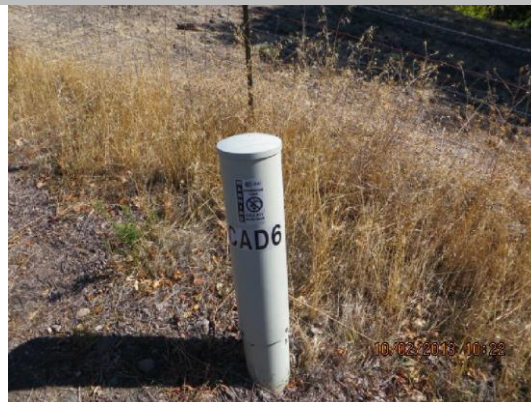
Photo 2 of 3 : UCIP_SP_2018_40789_39056.jpg

Communication line access box on WS shoulder.

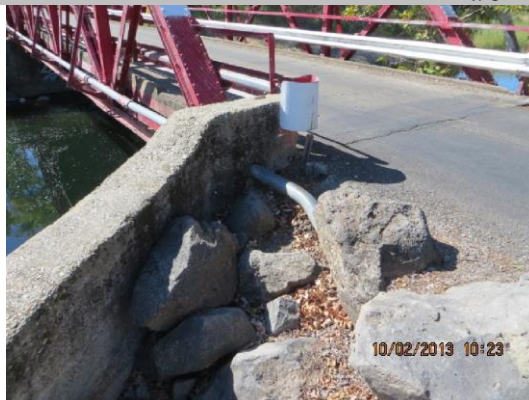
Photo 3 of 3 : UCIP_SP_2018_40789_39055.jpg

LM Start	0.31	Rating **	M	Issue No.	21 (cont)	
LM End	0.31	Issue Type +	En	Location *		
Category	Supplemental			GPS Latitude/Longitude		
				Start	End	
Item	DWR UCIP Field Study			39.970256 °	39.970256 °	
				-122.014471 °	-122.014471 °	
DWR ID						
Comment Code						
Inspector Comment						
FS_ID:40789 DS_ID:24683 EP_NO: N/A Repair Type: Non-Urgent Crossing Status: Found UCIP Comments: No permit identified for this crossing. FIELD_STRUCT_DESC: 4-inch galvanized iron communications conduit through the levee, at an unknown depth. Pipe visible on upstream side of bridge. FS Date: 10/2/2013

Communication line conduit visible on upstream side of bridge at WS.

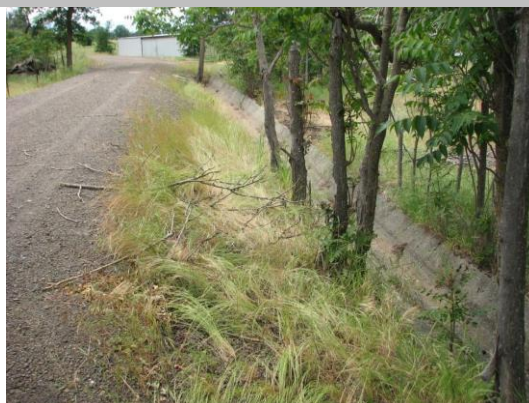
Photo 1 of 1 : SP_2018_NA0019_79_11_20180305_00006.jpg

LM Start	0.32	Rating **	M	Issue No.	11
LM End	0.34	Issue Type +	En	Location *	LS
Category	Earthen Levee			GPS Latitude/Longitude	
				Start	End
Item	Encroachments			39.970193 °	39.970188 °
				-122.014738 °	-122.015034 °
DWR ID	DWR_NA0019_02_s_2016_11				
Comment Code					
DT : Ditch					
Inspector Comment					
Concrete-lined.

View of a concrete-lined ditch along the levee toe.

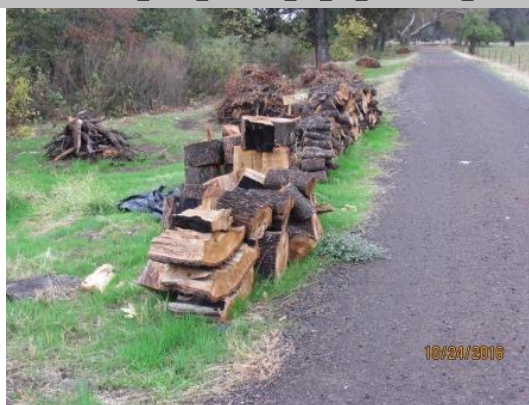
Photo 1 of 1 : SP_2018_NA0019_79_14_20180305_00009.jpg

LM Start	0.35	Rating **	M	Issue No.	14
LM End	0.35	Issue Type +	En	Location *	WS
Category	Earthen Levee			GPS Latitude/Longitude	
				Start	End
Item	Encroachments			39.970153 °	39.970153 °
				-122.015194 °	-122.015194 °
DWR ID	DWR_NA0019_02_f _ 2016_14				
Comment Code					
FW : Firewood					
Inspector Comment

View of the firewood along the waterside slope.

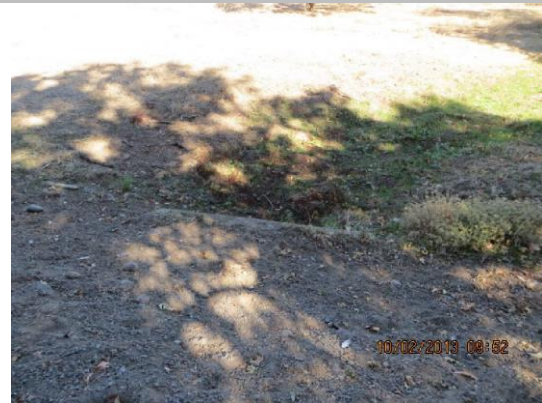
Photo 1 of 3 : UCIP_SP_2018_51442_36902.jpg

Comment Code					
Inspector Comment					
FS_ID:51442 DS_ID:20771 EP_NO: N/A Repair Type: Non-Urgent Crossing Status: Found UCIP Comments: 12/05/2016 Crossing has been downgraded from Urgent to Non-Urgent some debris blocking proper function of flapgate on WS. Recommend clearing debris from WS for flapgate to function properly. (O. Magana - DWR UCIP)10/01/2013 Debris blocking proper function of flapgate on WS toe. (W. Wylie - DWR UCIP) FIELD_STRUCT_DESC: 24-inch steel drainage pipe through the levee, 8.3 feet below the crown. Flap gate located on the waterside (WS) end. Concrete headwall located on the landside (LS). [Additional Reference(s): DWR Levee Log, 1992. USACE Sacramento O&M Manual Unit 509, March 1957, Unit 510, April 1963, Unit 511, May 1973, Unit 512, March 1964, Unit 513, December 1970, As-builts drawing 50-4-2394 (Station 155+40)]. FS Date: 12/5/2016

Concrete headwall at LS toe.

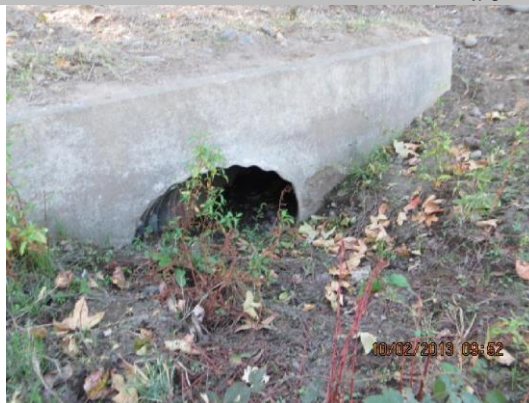
Photo 2 of 3 : UCIP_SP_2018_51442_36901.jpg

LM Start	0.68	Rating **	M	Issue No.	22 (cont)
LM End	0.68	Issue Type +	Ma	Location *

Concrete headwall at LS toe.

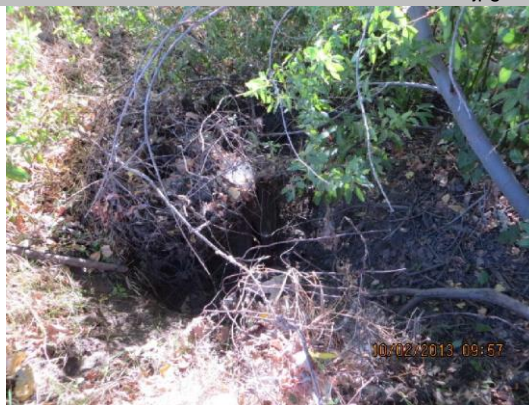
Photo 3 of 3 : UCIP_SP_2018_51442_36900.jpg

Outlet on WS toe.

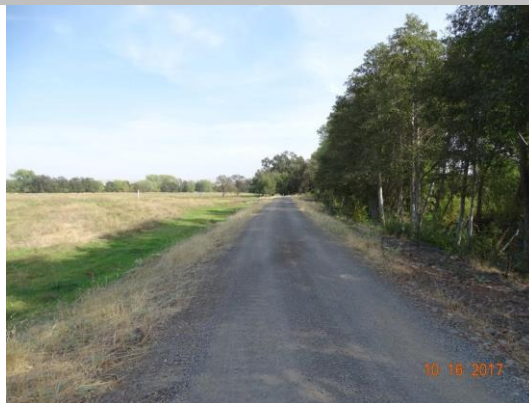
Photo 1 of 1 : SP_2018_NA0019_79_19_20180305_00011.jpg

LM Start	0.79	Rating **	M	Issue No.	19
LM End	1.50	Issue Type +	Ma	Location *	LS
Category	Earthen Levee			GPS Latitude/Longitude	
				Start	End
Item	Vegetation			39.968679 °	39.941069 °
				-122.022938 °	-122.064778 °
DWR ID	DWR_NA0019_02_f_2017_19				
Comment Code					
V2 : Remove the wild growth other than native grasses from the levee slopes.					
Inspector Comment					
Remove the native grasses from both slopes.

View of the native grasses on both slopes.

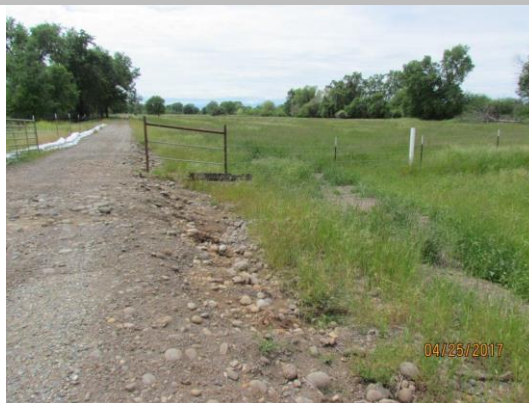
Photo 1 of 1 : SP_2018_NA0019_79_17_20180305_00010.jpg

LM Start	0.81	Rating **	M	Issue No.	17
LM End	0.85	Issue Type +	Ma	Location *	LS
Category	Earthen Levee			GPS Latitude/Longitude	
				Start	End
Item	Erosion / Bank Caving			39.968530 °	39.968248 °
				-122.023305 °	-122.023900 °
DWR ID	DWR_NA0019_02_s_2017_17				
Comment Code					
E2 : Schedule repair of erosion site prior to the next inspection.					
Inspector Comment					
Repair the erosion along the landside slope.

View of the erosion along the landside slope.

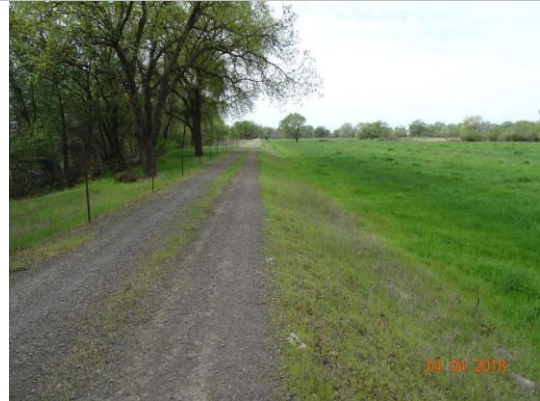
Photo 1 of 1 : SP_2018_NA0019_79_20_20180405_00019.jpg

LM Start	0.87	Rating **	A	Issue No.	20
LM End	0.87	Issue Type +	Ma	Location *	LS
Category	Earthen Levee			GPS Latitude/Longitude	
				Start	End
Item	Vegetation			39.968133 °	39.968133 °
				-122.024170 °	-122.024170 °
DWR ID	DWR_NA0019_02_s_2018_20				
Comment Code					
V1 : Control annual grass and weeds on the levee slopes and easements.					
Inspector Comment					
Native vegetation is well maintained on both slopes.

View of native vegetation on both slopes.

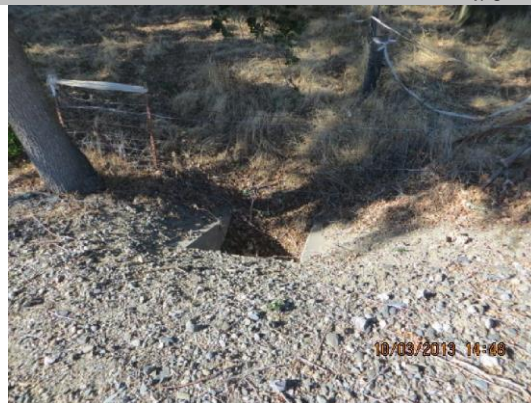
Photo 1 of 3 : UCIP_SP_2018_21793_37069.jpg

LM Start	0.51	Rating **	A/W	Issue No.	919
LM End	0.51	Issue Type +	Ma	Location *	
Category	Supplemental			GPS Latitude/Longitude	
				Start	End
Item	DWR UCIP LMA Responsibility			40.051211 °	40.051211 °
				-122.179663 °	-122.179663 °
DWR ID					
Comment Code					
Inspector Comment					
FS_ID:21793 DS_ID:20777 EP_NO: N/A Repair Type: No Action Needed Crossing Status: Found UCIP Comments: FIELD_STRUCT_DESC: 24-inch corrugated metal drainage pipe through the levee, 5 feet below the crown. Flap gate and concrete U-shaped headwall on the waterside (WS) end. Concrete U-shaped headwall on the landside (LS) end. [Additional Reference(s): DWR Levee Log, 1992. USACE Sacramento O&M Manual 510, April 1963, (HLM 0.52) Drawing No. 50-4-3622]. FS Date: 10/3/2013

Concrete U-shaped headwall on LS toe.

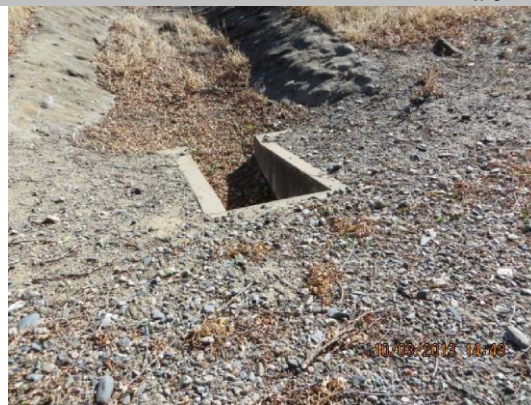
Photo 2 of 3 : UCIP_SP_2018_21793_37068.jpg

Concrete U-shaped headwall on WS toe.

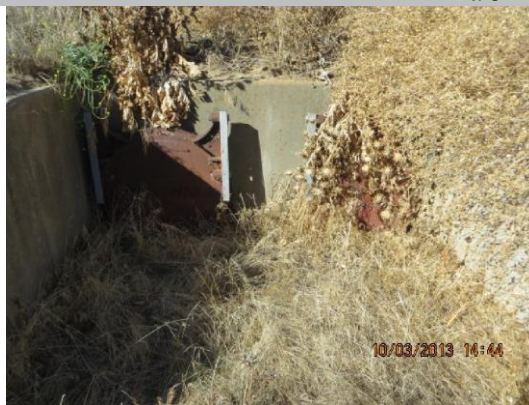
Photo 3 of 3 : UCIP_SP_2018_21792_37063.jpg

Concrete U-shaped headwall and flapgate on WS toe.

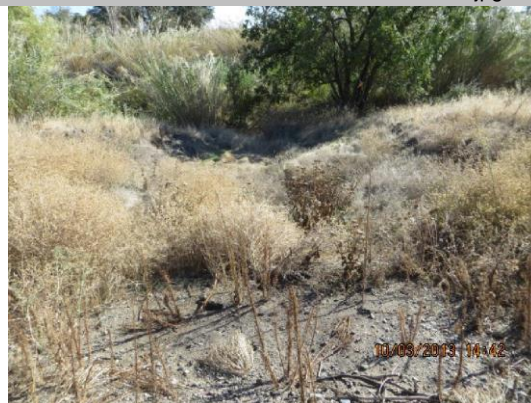
Photo 2 of 3 : UCIP_SP_2018_51443_37060.jpg

Concrete U-shaped headwall on WS toe.

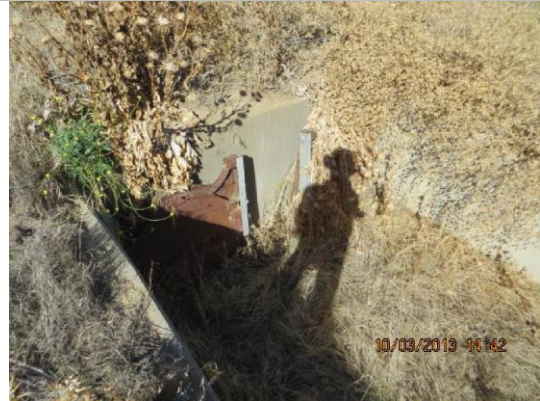
Photo 3 of 3 : UCIP_SP_2018_51443_37059.jpg

Comment Code						
Inspector Comment						
FS_ID:51443 DS_ID:20880 EP_NO: N/A Repair Type: Non-Urgent Crossing Status: Found UCIP Comments: 12/05/2016 Crossing has been downgraded from Urgent to Non-Urgent vegetation found on WS but does not appear to prevent proper function of flap gate. Recommend clearing dry vegetation on WS above concrete headwall.(O. Magana - DWR UCIP)10/03/2013 Flapgate operation hindered by soil and vegetation on WS toe. (W. Wylie - DWR UCIP) FIELD_STRUCT_DESC: 2 of 2: 36-inch corrugated metal drainage pipe through levee, 8.6 feet below crown. Flap gate and concrete "U" headwall located on the waterside (WS) end. Concrete "U" headwall located on the landside (LS) end. [Additional Reference(s): DWR Levee Log, 1992. USACE Sacramento O&M Manual, Unit 510, April 1963, As-built drawing No. 50-4-3622 (HLM 0.65)] FS Date: 12/5/2016

Concrete U-shaped headwall and flapgate on WS toe.

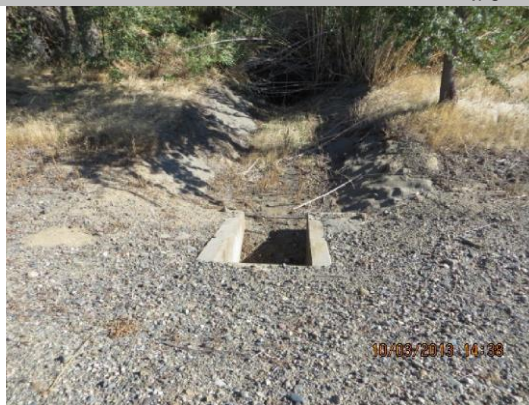
Photo 2 of 3 : UCIP_SP_2018_21790_37056.jpg

Concrete U-shaped headwall on WS toe.

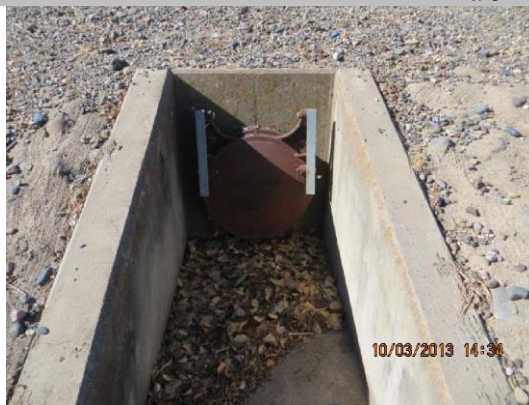
Photo 3 of 3 : UCIP_SP_2018_22827_38972.jpg

Flapgate on headwall at WS toe.

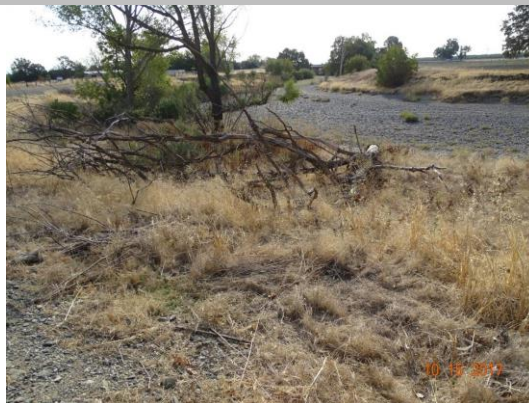
Photo 1 of 1 : SP_2018_NA0019_81_50_20180305_00023.jpg

LM Start	0.92	Rating **	M	Issue No.	50
LM End	0.92	Issue Type +	Ma	Location *	WS
Category	Earthen Levee			GPS Latitude/Longitude	
				Start	End
Item	Encroachments			40.053420 °	40.053420 °
				-122.172617 °	-122.172617 °
DWR ID	DWR_NA0019_04_f_2017_50				
Comment Code					
TR : Tree or limb					
Inspector Comment					
Remove the tree from the waterside toe.

View of the tree along waterside toe.

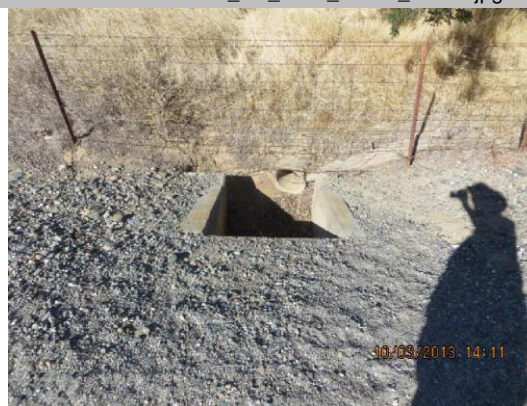
Photo 1 of 3 : UCIP_SP_2018_21778_37037.jpg

Concrete U-shaped headwall on LS toe.

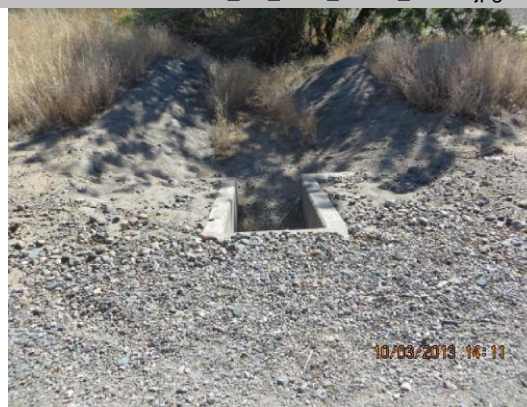
Photo 2 of 3 : UCIP_SP_2018_21778_37036.jpg

Concrete U-shaped headwall on WS toe.

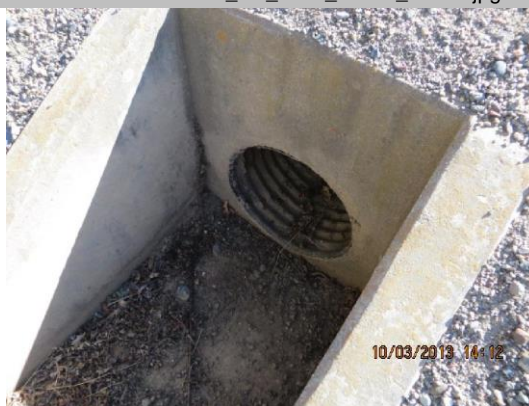
Photo 3 of 3 : UCIP_SP_2018_21778_37035.jpg

Concrete U-shaped headwall on LS toe.

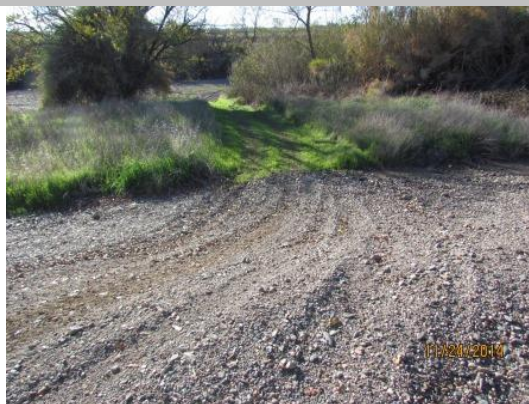
Photo 1 of 1 : SP_2018_NA0019_81_16_20180305_00011.jpg

LM Start	1.39	Rating **	M	Issue No.	16
LM End	1.39	Issue Type +	Ma	Location *	WS
Category	Earthen Levee			GPS Latitude/Longitude	
				Start	End
Item	Slope Stability			40.051493 °	40.051493 °
				-122.164935 °	-122.164935 °
DWR ID	DWR_NA0019_04_f_2014_16				
Comment Code					
S3 : Repair the levee slope damaged by vehicle traffic and prevent access where possible.					
Inspector Comment

View of the slope instability caused by vehicles along the waterside slope.

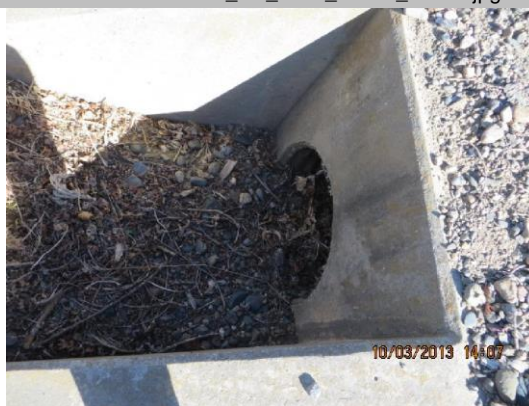
Photo 3 of 3 : UCIP_SP_2018_21776_37027.jpg

Concrete U-shaped headwall on LS toe.

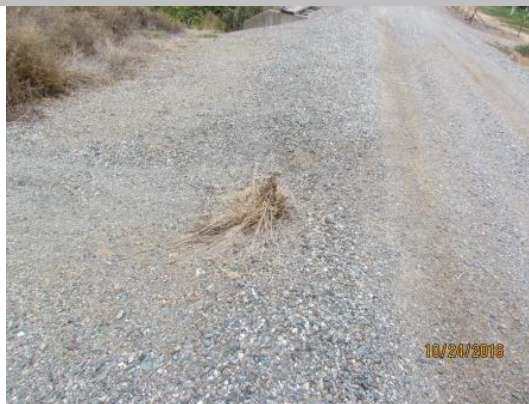
Photo 1 of 2 : SP_2018_NA0019_81_3_20180305_00003.jpg

LM Start	1.59	Rating **	M	Issue No.	3
LM End	1.59	Issue Type +	Ma	Location *	WS
Category	Earthen Levee			GPS Latitude/Longitude	
				Start	End
Item	Slope Stability			40.052607 °	40.052705 °
				-122.161418 °	-122.161442 °
DWR ID	DWR__04_s_2012_3				
Comment Code					
S3 : Repair the levee slope damaged by vehicle traffic and prevent access where possible.					
Inspector Comment					
Tehama Co. repaired the slope that was damaged by vehicle traffic, but the damage has returned. On 4/26/16, vehicle erosion area was repaired again, but should be monitored.

View of a dip along the levee slope.

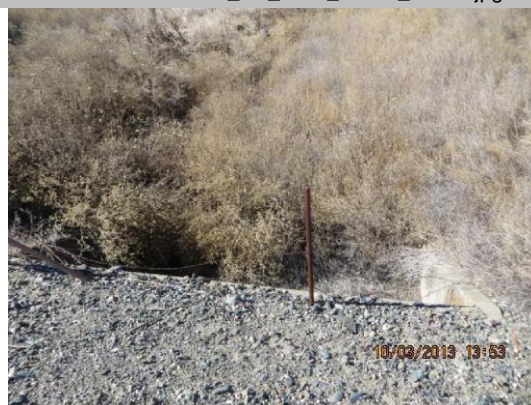
Photo 1 of 3 : UCIP_SP_2018_21769_37004.jpg

Concrete inlet on LS toe.

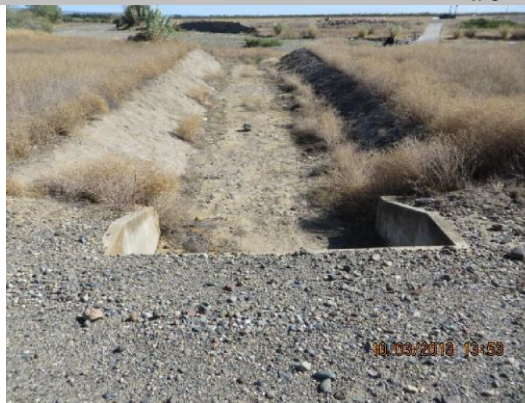
Photo 2 of 3 : UCIP_SP_2018_21769_37003.jpg

Concrete inlet on WS toe.

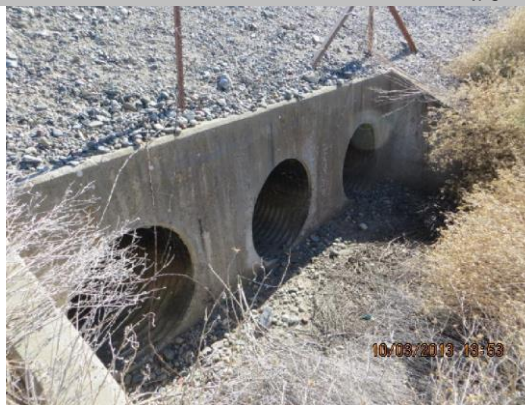
Photo 3 of 3 : UCIP_SP_2018_21769_37002.jpg

Concrete inlet on LS toe.

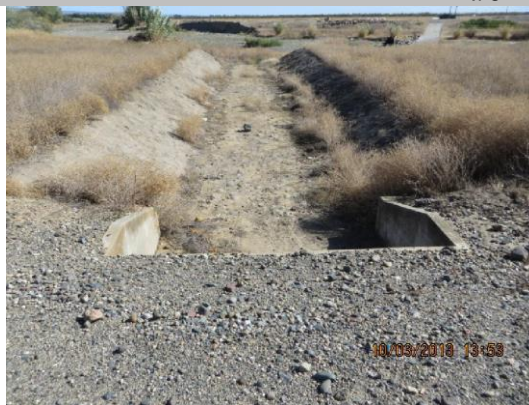
Photo 2 of 3 : UCIP_SP_2018_21768_36999.jpg

Concrete headwall on WS toe.

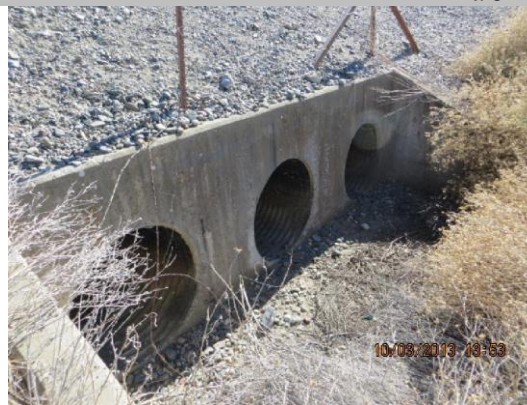
Photo 3 of 3 : UCIP_SP_2018_21767_36994.jpg

Concrete headwall on LS toe.

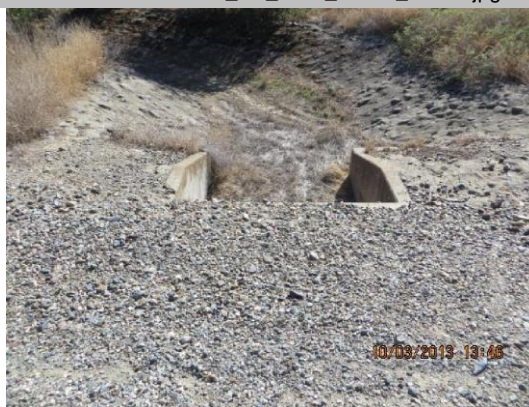
Photo 2 of 3 : UCIP_SP_2018_21766_36991.jpg

Concrete headwall on WS toe.

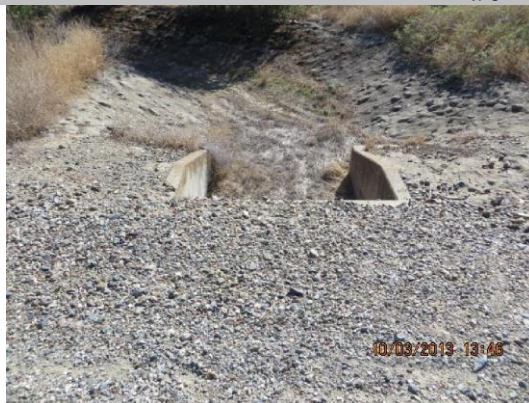
Photo 2 of 3 : UCIP_SP_2018_22828_38977.jpg

Concrete headwall and concrete channel on WS toe.

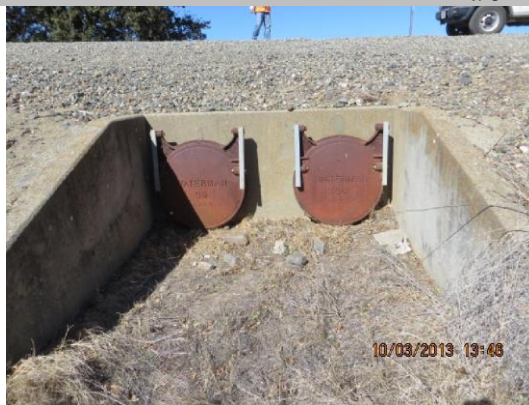
Photo 3 of 3 : UCIP_SP_2018_22828_38980.jpg

Flapgate on headwall at WS toe.

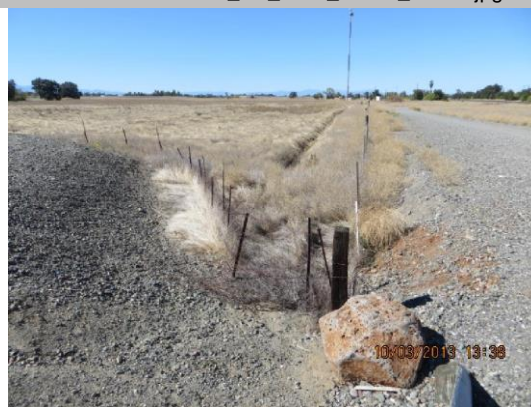
Photo 2 of 3 : UCIP_SP_2018_21763_36981.jpg

Inlet off LS toe in channel.

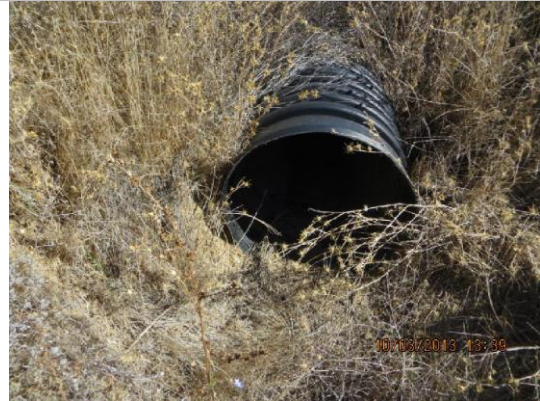
Photo 3 of 3 : UCIP_SP_2018_21763_36980.jpg

HDPE pipe inlet on LS toe.

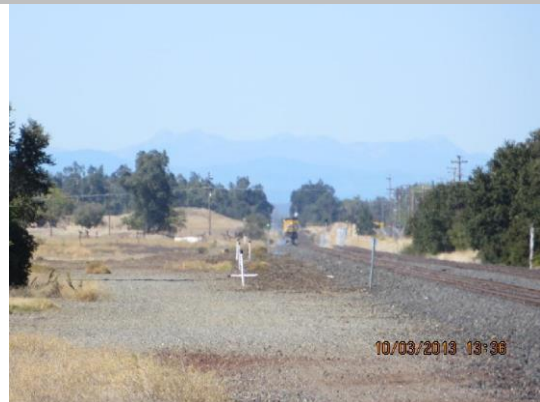
Photo 1 of 1 : UCIP_SP_2018_23051_39135.jpg

LM Start	2.23	Rating **	M	Issue No.	934
LM End	2.23	Issue Type +	En	Location *	
Category	Supplemental			GPS Latitude/Longitude	
				Start	End
Item	DWR UCIP Field Study			40.052063 °	40.052063 °
				-122.150450 °	-122.150450 °
DWR ID					
Comment Code					
Inspector Comment					
FS_ID:23051 DS_ID:24695 EP_NO: N/A Repair Type: Non-Urgent Crossing Status: Found UCIP Comments: No permit identified for this crossing. FIELD_STRUCT_DESC: Fiber optics conduit of an unknown size or material through the levee, at an unknown depth. Signage on the landside (LS) visible. FS Date: 10/3/2013

Fiber optic line markers off LS shoulder.

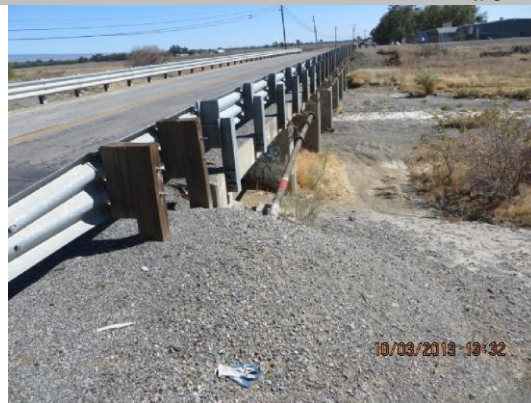
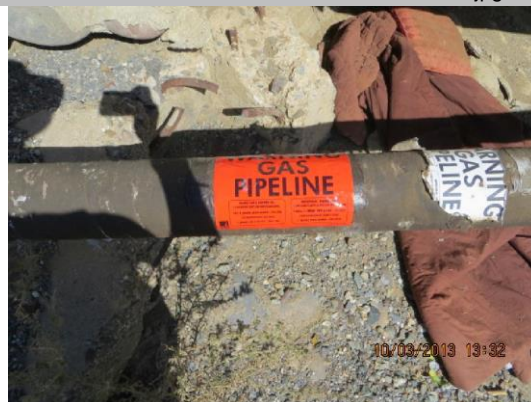
LM Start	2.28	Rating **	M	Issue No.	935	
LM End	2.28	Issue Type +	En	Location *		
Category	Supplemental			GPS Latitude/Longitude		
				Start	End	
Item	DWR UCIP Field Study			40.052379 °	40.052379 °	
				-122.149534 °	-122.149534 °	
DWR ID						
Comment Code						
Inspector Comment						
FS_ID:23045 DS_ID:24694 EP_NO: N/A Repair Type: Non-Urgent Crossing Status: Found UCIP Comments: No permit identified for this crossing. FIELD_STRUCT_DESC: 4-inch coated steel gas pipeline through the levee, 3.5 feet below the crown. Pipe visible on upstream side of bridge. FS Date: 10/3/2013

Gasline on upstream side of bridge.
